Shop Tips

JANUARY, 1964

FROM
FORD

Technical parts and service information published by Ford Division to assist servicemen in Service Stations, Independent Garages and Fleets.

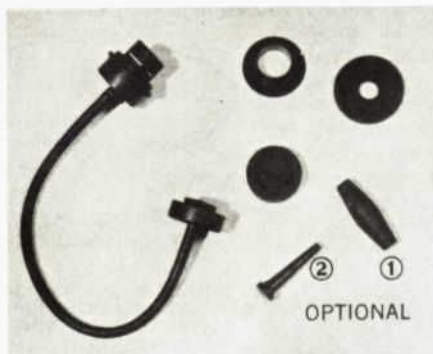
Figure 3—Emission System Tester Components and Adaptors

be used. (Figure 3.) This tester will give an accurate visual indication of the need for service.

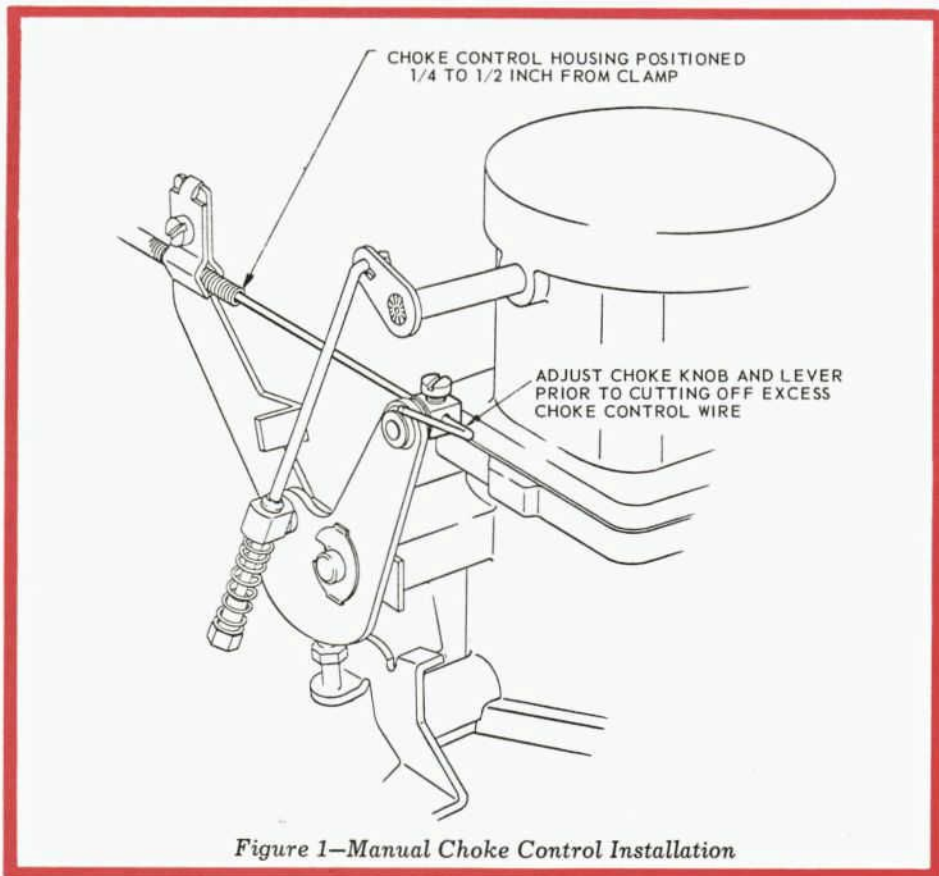
Figure 1—Manual Choke Control Installation

Difficulty in starting 1963 six cylinder engines with a manual choke may be attributed to choke cable interference. This is caused by an excessive length of choke control wire interfering with the pull-down rod or choke shaft lever.

This condition can be corrected by cutting off the excessive length of choke wire as shown in Figure 1. Prior to cutting the choke wire, check the control housing for proper installation in the clamp at the carburetor. The end of the control housing should extend 1/4 to 1/2 inch beyond the clamp.

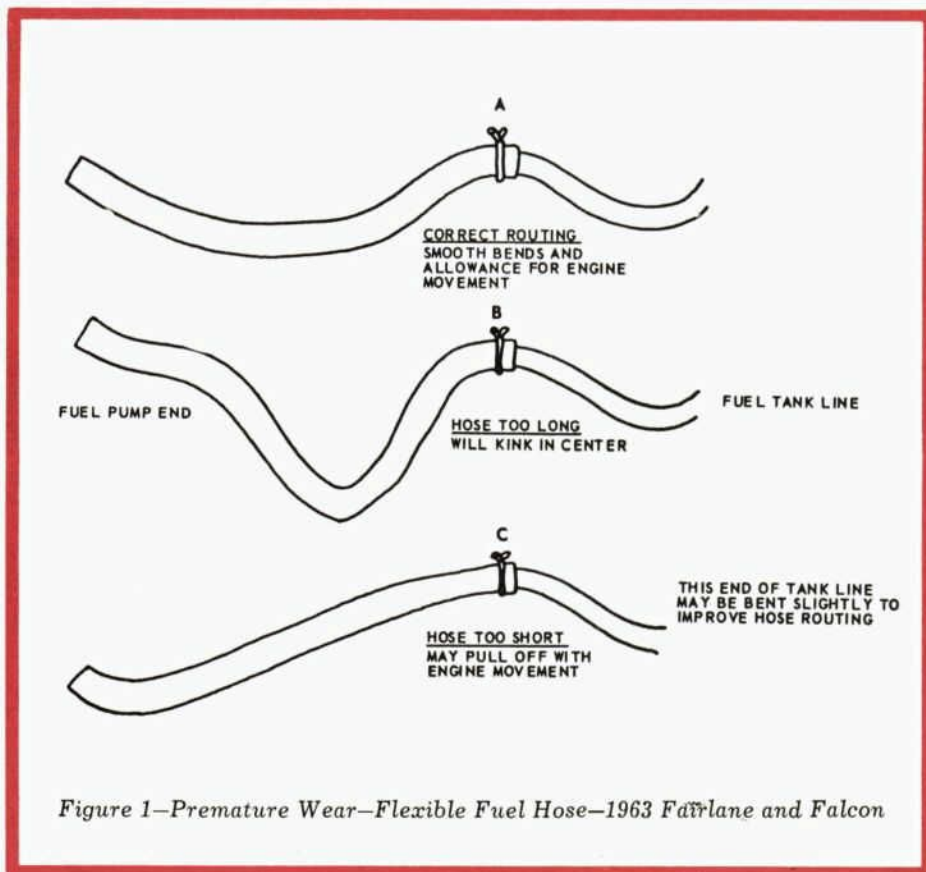
Figure 1—Premature Wear—Flexible Fuel Hose—1963 Fairlane and Falcon

If the flexible fuel line between the fuel pump and the fuel tank line is the incorrect length, it can result in a kinked condition causing fuel starvation of the engine, or premature wear with eventual leakage.

If the fuel hose is too long and kinked as shown in Fig. 1-B, the hose should be shortened to about 7 $\frac{3}{4}$ inches for a smooth routing. See Fig. 1-A.

If the fuel hose is too short and stretched as in Fig. 1-C, it is necessary to bend the front end of the fuel tank line to obtain a smooth routing without stretching of the flexible fuel line. See Fig. 1-A.
