SHOP TIPS

VOL. 5, NO. 11

JULY-AUGUST 1967

ROUGH ENGINE

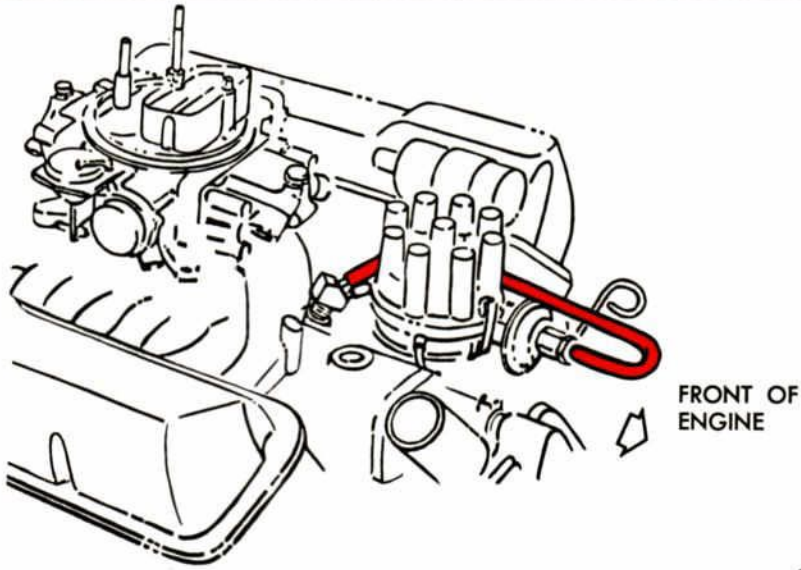
Fig. 1—Typical Intake Manifold Connection

I—Intake manifold (see typical installation in Figures 1 & 2).

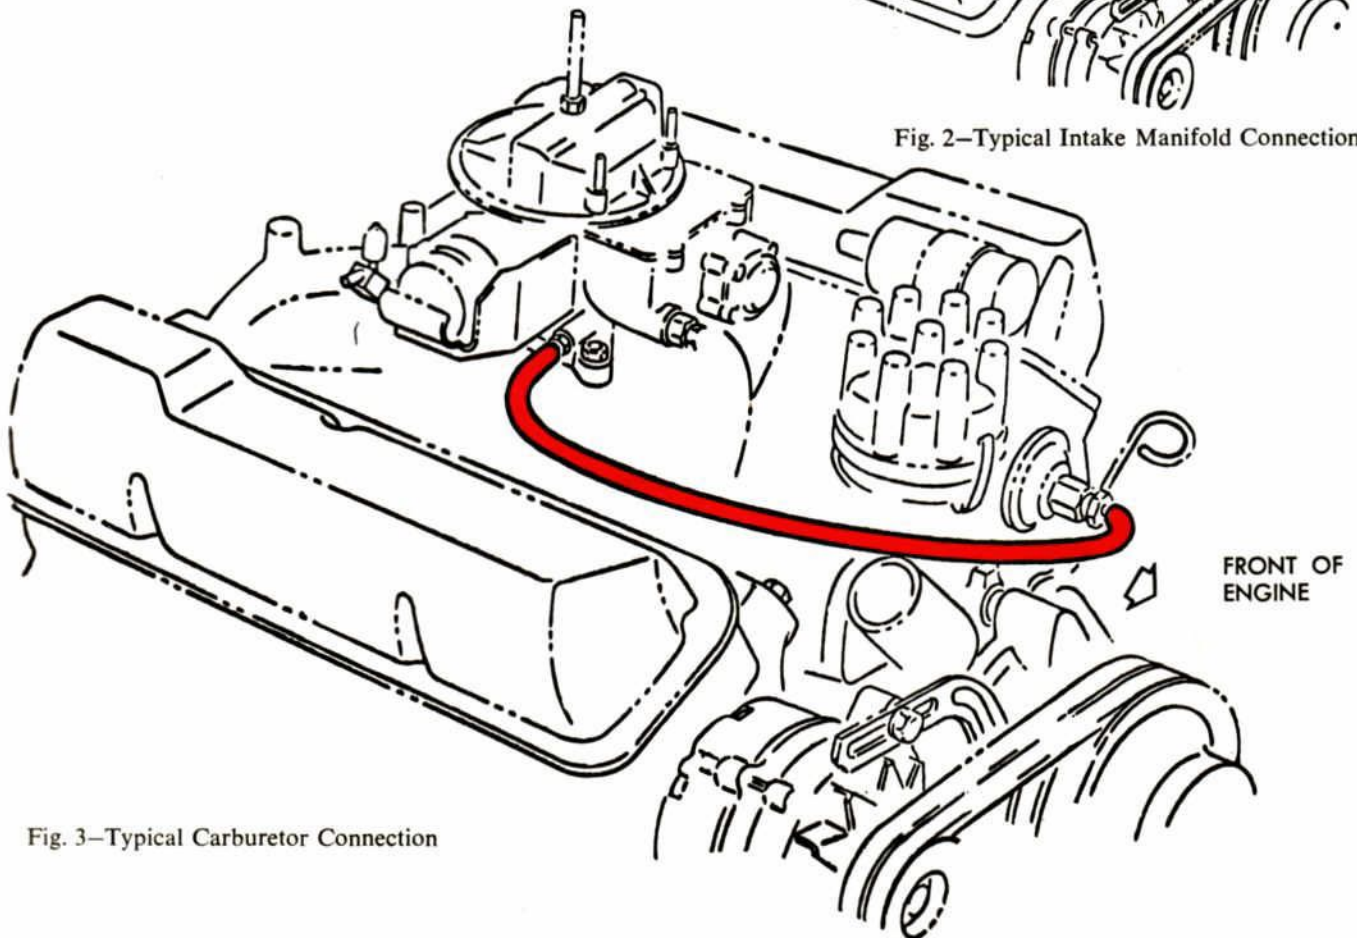
Fig. 3—Typical Carburetor Connection

C—Carburetor (see typical installation in Figure 3).

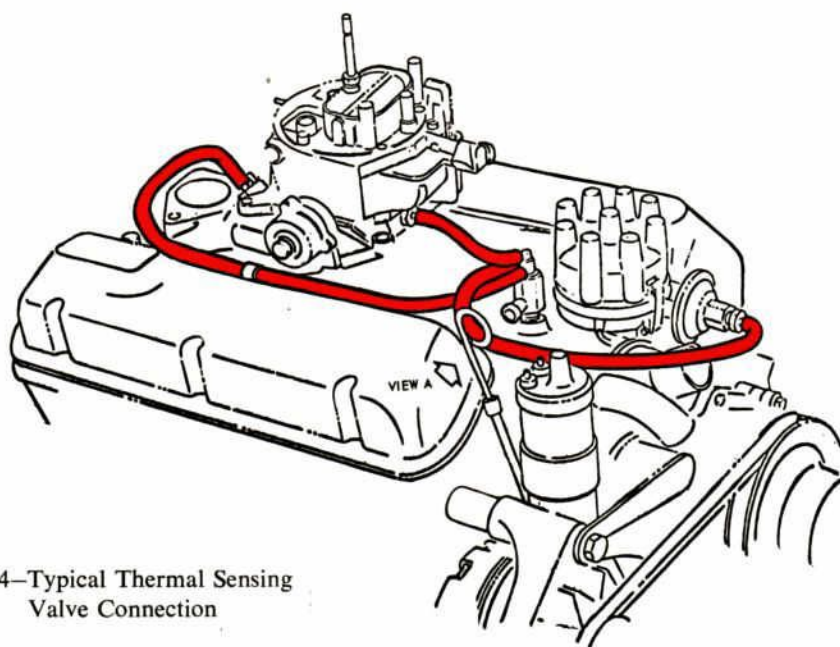
Fig. 4—Typical Thermal Sensing Valve Connection

T—Thermal sensing—This is a new device that switches the vacuum source between the intake manifold and the carburetor as explained in the March, 1967 issue of Shop Tips (see typical installation in Figure 4).

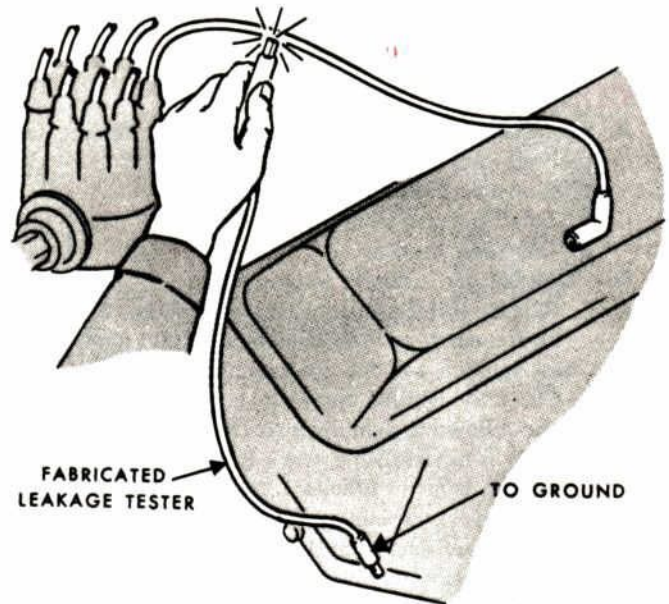
Leakage Test

B. LEAKAGE TEST: In addition to high resistance, insulation failure (puncture and leakage of the spark plug wire to ground) of the plug wire can also cause plug misfire and rough engine operation. Dielectric failure or leakage of the plug wire can be checked in the following manner.

Spark plug wires which exhibit leakage should be replaced, however corona should not be mistaken as spark leakage. Corona is merely the glowing that appears caused by the electrical stress in the air adjacent to the spark plug wire. This is not a malfunction.

1. Fabricate a leakage tester by using a 30-36 inch piece of 14 gauge insulated wire with two insulated alligator clips attached to the wire ends.
2. Remove and open circuit the plug wire at the spark plug. Note: Position the plug boot so that the wire will not fire to ground through the open boot end.
3. Attach one clip of the fabricated wire to ground and with the engine running, move the remaining clip on the wire along the entire length and circumference of the spark plug wire. Punctures and/or leakage of the wire insulation will be evidenced by the presence of a bright spark or arc through the insulation of the spark plug wire to the alligator clip to ground. See illustration.

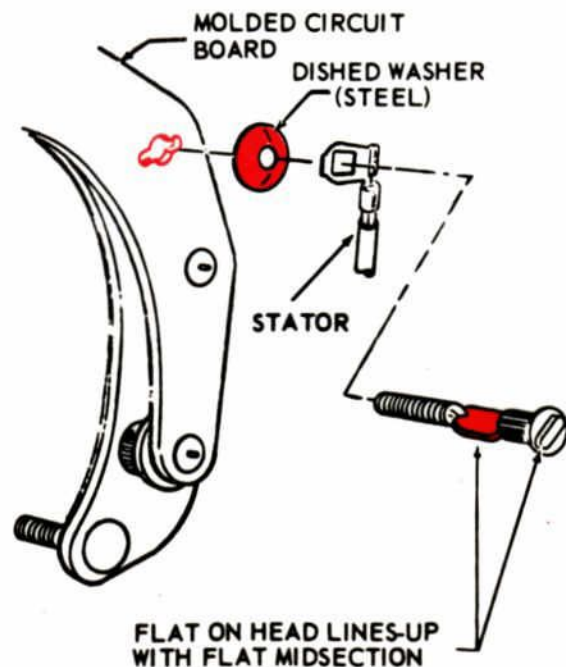
Molded Circuit Board

The molded circuit board is used in approximately 50% of the Autolite alternators. This type circuit board utilizes retaining screws with a flattened midsection, which act as a locking device. To prevent damage to the board during removal, the screw must be turned so the flat lines-up with the slot. Do not attempt to force the screw out of the board while it is in the lock position. (See illustration.)

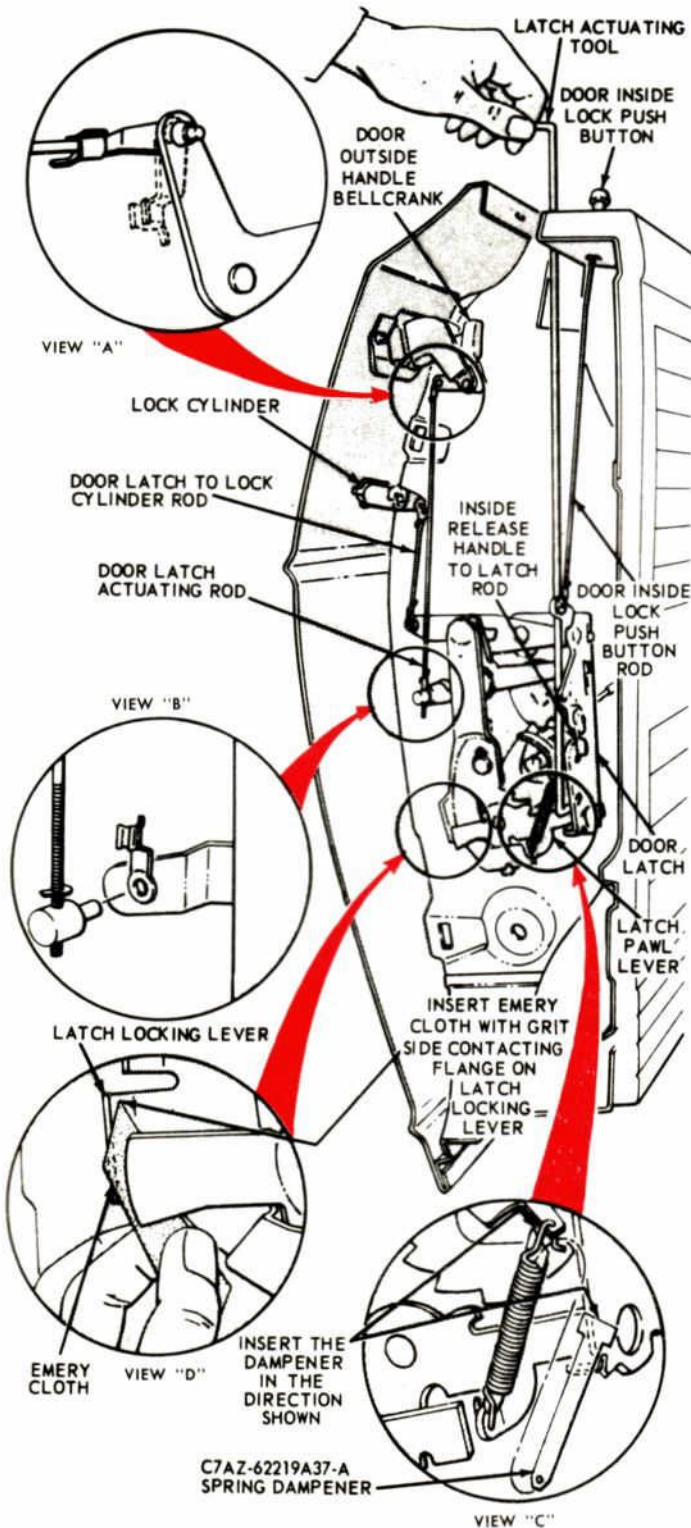
Fig. 2—Ford and Thunderbird Latch System Shown—Other Systems Typical

Ford, Mercury, Thunderbird and Lincoln Only—A plastic strip which functions as a sound deadener is inserted in the door latch pawl spring during latch assembly. If the pawl spring dampener is missing, the spring will transmit an objectionable tuning fork type noise as the door is closed.

If the door latch spring dampener (Fig. 2—View C) is missing, procure a service released dampener (Ford Part Number C7AZ-62219 A37-A) or fabricate one as shown in Figure 6 from mylar or similar soft plastic material. Insert the dampener into the spring as shown in Figure 2, View C.

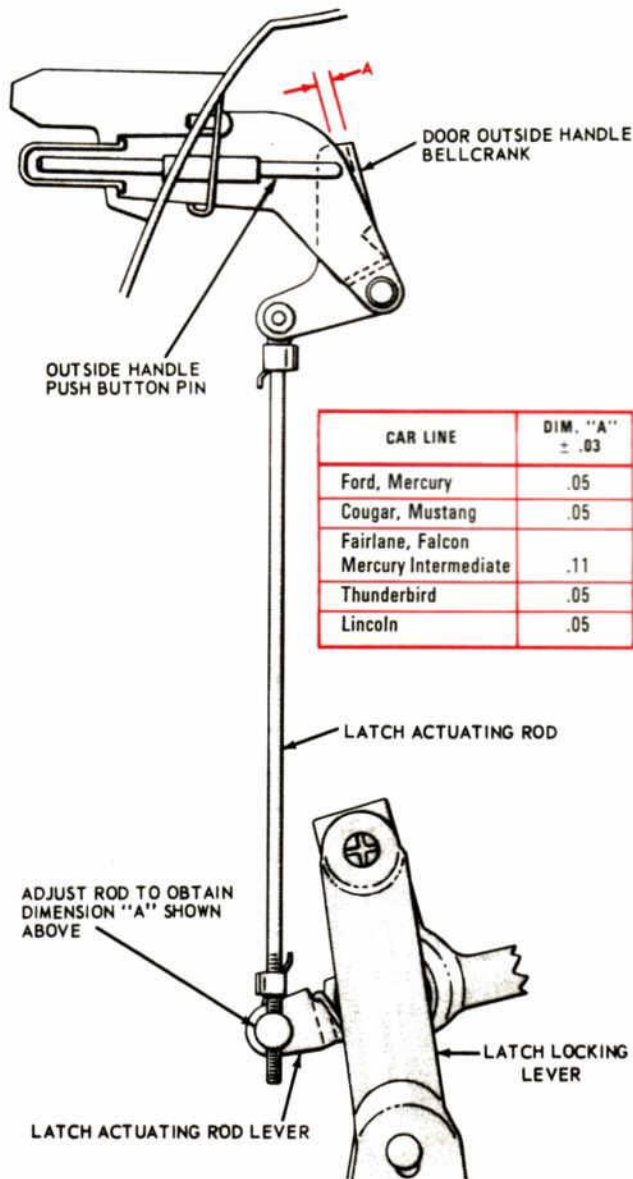
Fig. 4—Door Latch Adjustment

If no distinct free play is evident when a slight pressure is applied to the door handle outside push button, the door latch actuating rod (Fig. 4) has been adjusted too short. This condition pre-loads the latch so that when the door is closed and then locked (inside lock push button depressed), the latch locking lever will travel past the latch pawl and restrict the necessary upward movement of the locking lever to unlock the door. (Fig. 5—View A).

Disengage the latch actuating rod at the latch (Fig. 4) and adjust the length of the rod so that the gap between the door handle bell crank and push button pin is set to the appropriate dimension shown in Fig. 4.

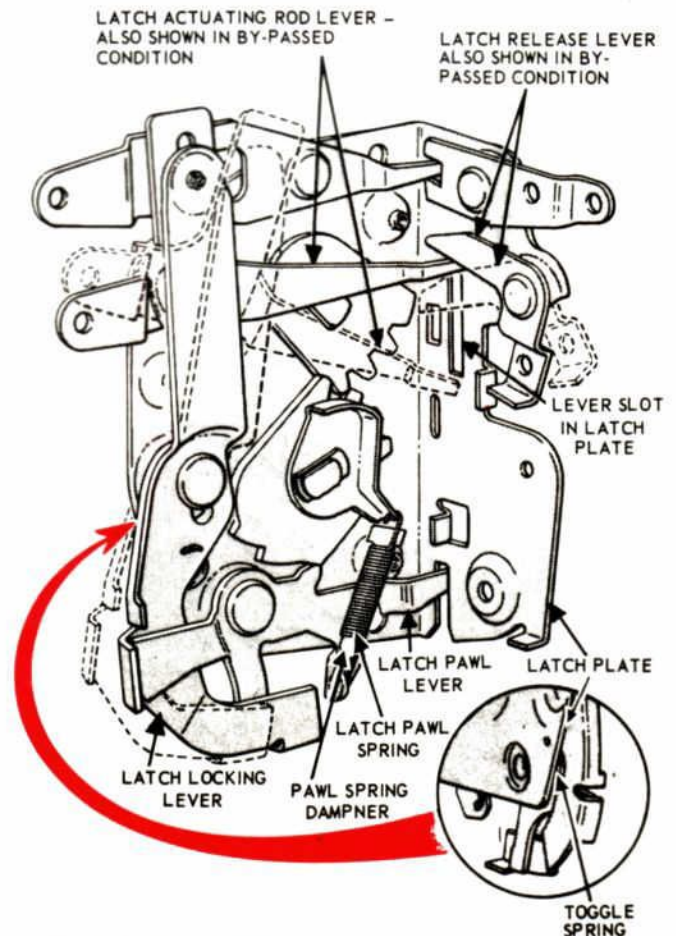
Fig. 5—Locking Lever

This condition causes the latch actuating rod lever to remain in an actuated position and prevents the locking lever from returning to its normal "free" position (Fig. 5 illustrates this condition). If this problem occurs, latch assembly replacement is necessary.

Ford, Mercury, Thunderbird and Lincoln Only—Inspect the latch to determine if the release lever has by-passed the latch actuating rod lever. This condition (shown in Fig. 5) prevents the release lever from returning to its normal position and latch assembly replacement is necessary for problem correction.

All Car Lines—Review the door latch and determine if the door latch locking lever toggle spring is missing (see Fig. 5). This is evident if the inside lock push button can be moved up and down freely. Also, by inspecting the latch with the door inside lock push button in the "unlocked" (up) position, it can be readily determined if the toggle spring is missing.

If the toggle spring is missing, remove the latch from the door and procure one of the following service replacement toggle springs noted below:

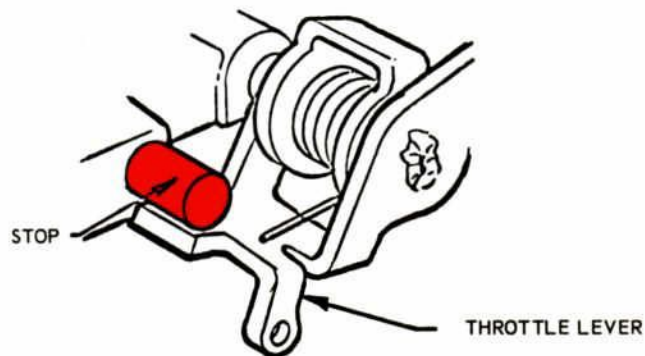
Fig. 1—Carburetor Throttle Stop

A possible cause of the subject condition, very often overlooked, is that of improper throttle linkage (cable or rod type) adjustment. This adjustment should, in fact, be the initial step in the diagnosis of this condition, to avoid unnecessary corrective efforts. Improper adjustment not only limits engine performance, but the carburetor dechoke system will not function should a flooded starting condition occur.

LEVER SHOULD CONTACT STOP AT W.O.T. POSITION

1. Remove the air cleaner.
2. From the passenger's compartment, observe the throttle linkage with the accelerator fully depressed. The throttle lever on the carburetor should touch the throttle stop on the carburetor base (Fig. 1).
3. If the throttle lever does not contact the stop, check for carpet interference and/or adjust the linkage as necessary for full throttle lever travel.

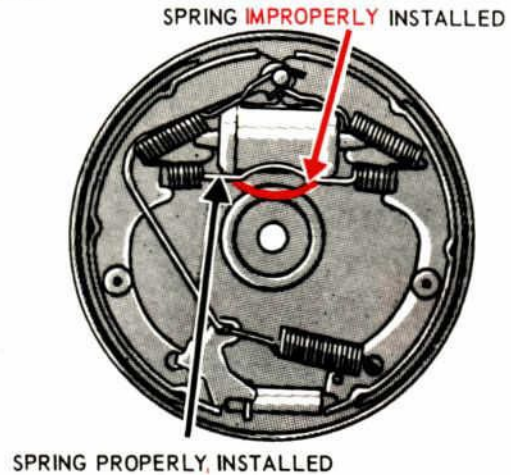
Fig. 2—Brake Shoe Retracting Spring

Installing the brake shoe retracting assist spring improperly, results in a scraping noise emanating from the affected front brake assembly. The proper installation of the spring is with the loop toward the wheel cylinder (see Fig. 2).

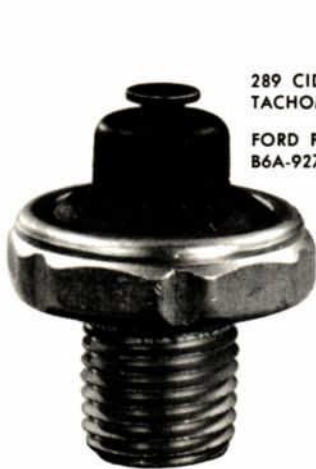
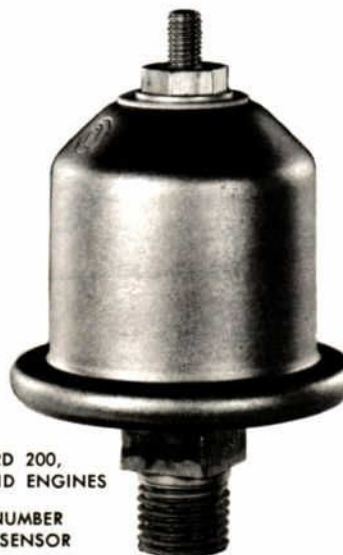
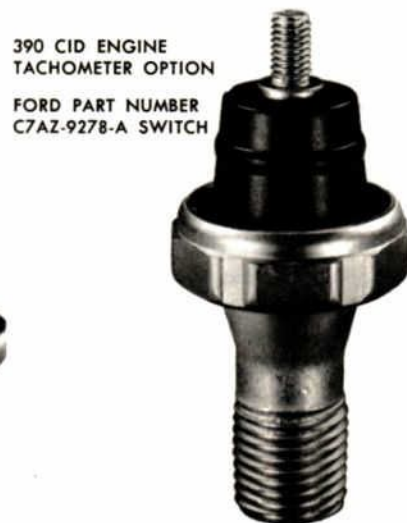
The oil pressure sending units of the two systems are NOT interchangeable. Misuse of the sending units causes the

- The indicator gauge (standard system) will be damaged if it's used with the pressure switch (optional system).
- The warning light (optional system) will not glow if it's used with the oil pressure sensor (standard system).

If necessary to replace the oil sending unit of a 1967 Mustang, be sure the correct type is installed (as illustrated) to avert the above conditions.
