# Shop Tips FROM FORD

VOL. 2, NO. 3

Technical parts and service information published by Ford Division to assist servicemen in Service Stations, Independent Garages and Fleets.

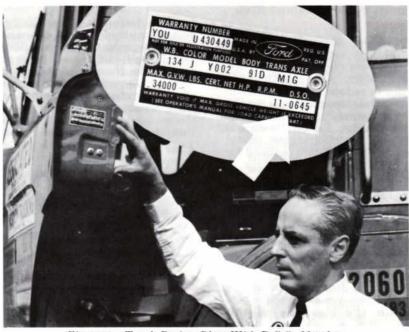
Figure 1-Truck Rating Plate With D.S.O. Number

All "D.S.O." vehicles are easily identified by the D.S.O. number which is found in the lower right hand corner of the truck rating plate or passenger car warranty plate. (See figure 1.) On certain plates you may find a D.S.O. number such as 11-, without a second set of digits. (See figure 2.) This is not a special vehicle. This number refers only to the District in which a standard vehicle was delivered.

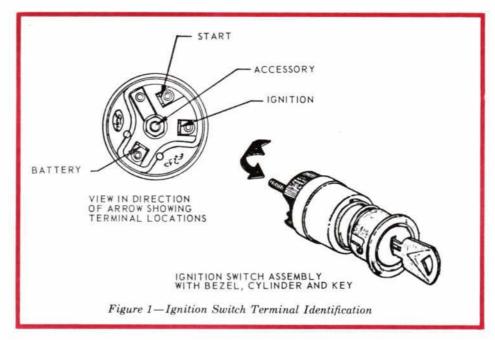
In some instances where the ignition switch may appear to be defective, the electrical problem may not lie in the switch itself, but in some other area of the vehicle. In order to aid servicemen in their diagnosis of this problem, a continuity checking procedure is outlined below. This continuity check should be completed before assuming that the ignition switch is defective.

After disconnecting the battery and removing the ignition switch from the instrument panel, a self powered continuity checker should be used in the following manner: (See figure 1 for terminal identification).

- The remaining lead will be used as follows:
  - A. With the key at the "Off" position, there should be no continuity at any of the three remaining terminals ("Accessory", "Ignition", or "Start".)
  - B. With the key at the "Accessory" position, there should be continuity at the "Accessory" terminal only.
  - C. With the key at the "On" position, there should be continuity at the "Accessory" and "Ignition" terminals only.
- D. With the key held at the "Start" position, there should be continuity at the "Start" and "Ignition" terminals only.

NOTE: A check for internal groundings of the switch to the metal housing must be made in conjunction with the above tests. If the switch performs these tests satisfactorily, it should be reinstalled, and investigation in other areas should be undertaken to isolate the electrical problem.

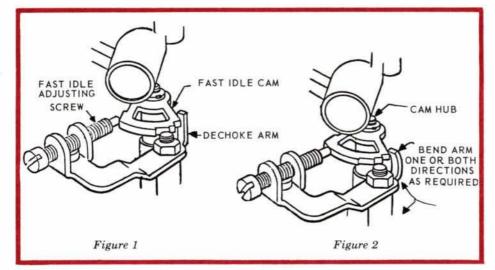
Poor cold-engine starts, due to low engine idle speeds, may be caused by the fast idle adjusting screw riding over the top of the high step on the fast idle cam, or the fast idle cam falling down beyond the unloader tang. This condition can be readily diagnosed by running the engine at about 2000 R.P.M. Rotate the fast idle cam adjusting lever upward and allow the engine to return to idle. A low idle R.P.M. may indicate the fast idle adjusting screw is not in contact with the cam (refer to Figure 1), while a high idle R.P.M. indicates the adjusting screw is on the high step of the cam.

The cam fall-down problem can be corrected by bending the dechoke arm on the fast idle throttle lever inward (toward the throttle shaft). The arm should be bent inward sufficiently (eight degrees minimum) to prevent the cam fall-down as well as unloading the choke. (Refer to Figure 2.)

Check the dechoke plate clearance. This is the distance between front edge of the choke plate and the air horn at wide throttle with a cold choke (plate initially closed). This should be 1/16 in. minimum. If necessary, bend the dechoke arm toward the fast idle cam hub to increase the dechoke clearance.

Set the fast idle R.P.M. to the following specifications (with the screw on the kick-down step of the fast idle cam as noted by the arrow mark). 260-2V and 289-2V Engines:
