Shop Tips

DECEMBER, 1964

FROM FORD

3 SPECIAL FEATURES !

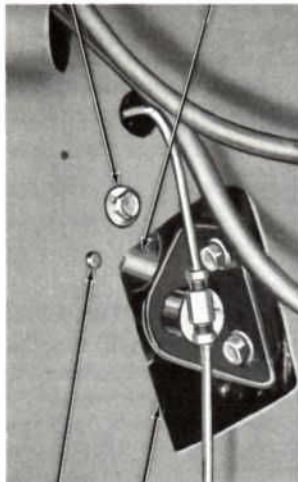
Figure 9

RETAINING BOLT PROPORTIONING VALVE

MOUNTING TANG FENDER APRON

3. Working underneath the left fender, remove the bolt that retains the proportioning valve to the fender apron and remove the valve through the access hole (Figure 9).

1. From underneath the left fender, install the proportioning valve through the access hole in the fender apron. Position the valve to the apron so that the mounting tang extends through the hole in the fender apron as shown in Figure 9. Install the retaining bolt.

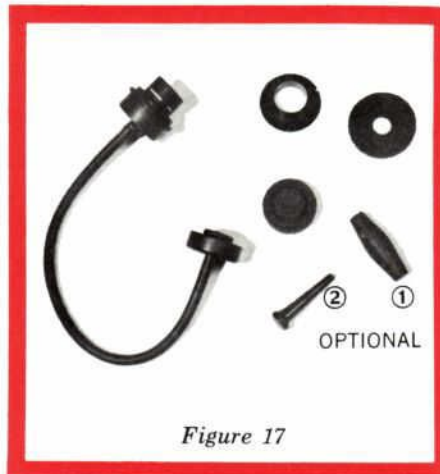
Figure 17

The PCV System works well only if properly maintained. In order to test its efficiency the AC Tester CT-1 can be used. See Figure 17. This tester will give an accurate visual indication of the need for service.

The tester will check the PCV System used on all Ford engines as well as other make vehicles. Set the tester to number 2 for all Ford engines except 144 and 170 C.I.D. engines, which require a number 4 setting. The tester will let the customer see for himself if he needs emission service. With the exception of the tester setting for Ford engines given above, complete operating instructions are provided with the tester.
