Shop Tips

JANUARY, 1964

FROM
FORD

Technical parts and service information published by Ford Division to assist servicemen in Service Stations, Independent Garages and Fleets.

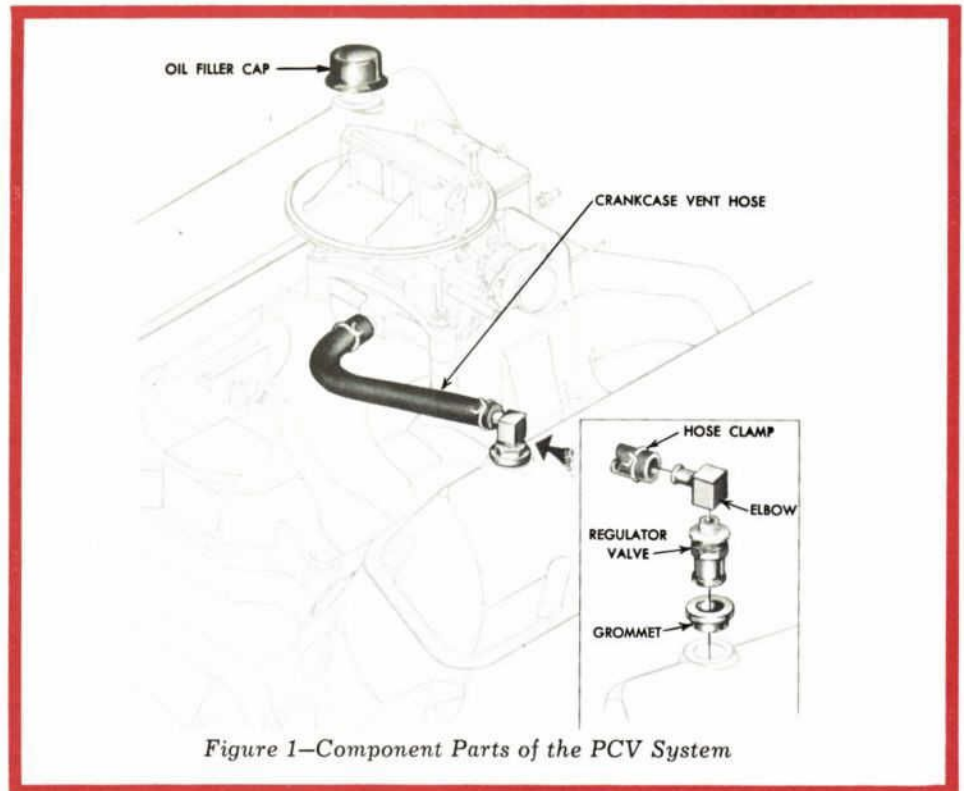
Figure 1—Component Parts of the PCV System

The air flow in the Positive Crankcase Ventilation System is shown on the front cover. Also see Figure 1 for component parts of the PCV System.

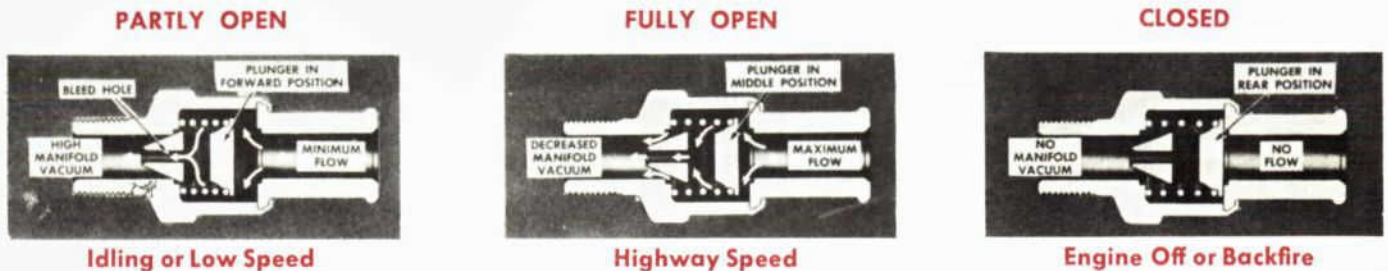
Figure 2—Emission System Valve Operation

Vacuum, which is greatest when the engine is idling or at low speed, pulls the tapered plunger forward to seat against the valve housing, restricting the vapor flow to the center bleed hole. (left hand Figure 2.) At highway speed with decreased vacuum, the spring moves the plunger to the fully opened (middle position Figure 2), for maximum flow around the plunger and through the bleed hole. With the ignition off, manifold vacuum drops to zero and the spring moves the plunger to a closed position (right hand Figure 2). In the event of backfire, back pressure will also cause the plunger to close.
