SHOP TIPS

VOL. 5, NO. 11

JULY-AUGUST 1967

ROUGH ENGINE

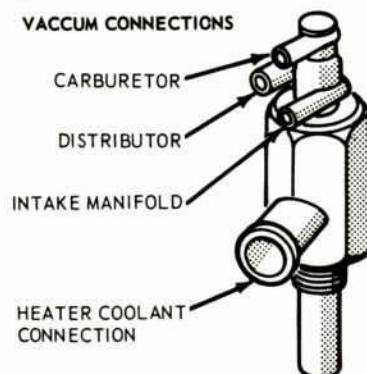
Fig. 4—Typical Thermal Sensing Valve Connection

T—Thermal sensing—This is a new device that switches the vacuum source between the intake manifold and the carburetor as explained in the March, 1967 issue of Shop Tips (see typical installation in Figure 4).

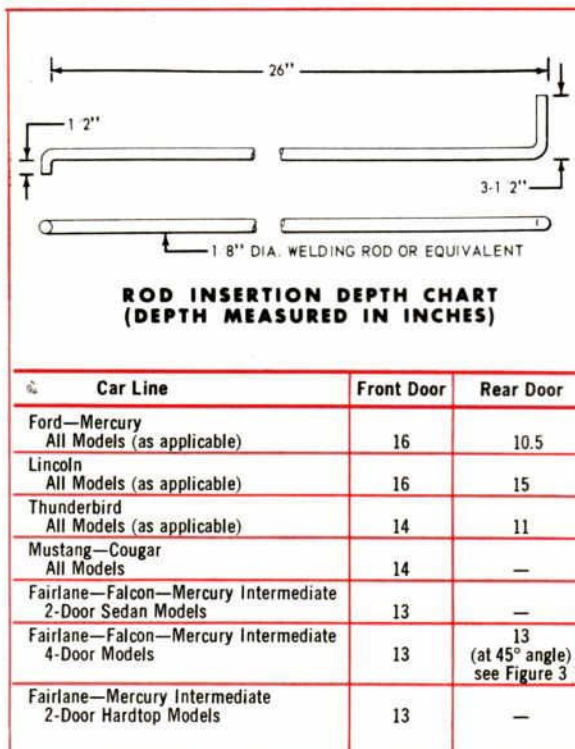
Fig. 1—Rod Actuating Tool and Rod Insertion Depth Chart

Fabricate a latch actuating tool from $\frac{1}{8}$ inch diameter welding rod or equivalent as shown in Figure 1.

Enter the vehicle through the opposite door and lower the side glass of the inoperative door to the full "down" position. From outside the vehicle, insert the fabricated tool through the glass opening at the latch end of the door and engage the door latch pawl lever as shown in Figure 2. A slight downward pressure will then unlatch the door. The chart shown with Figure 1 will assist in determining for each car line the approximate depth the rod should be inserted to engage the latch.

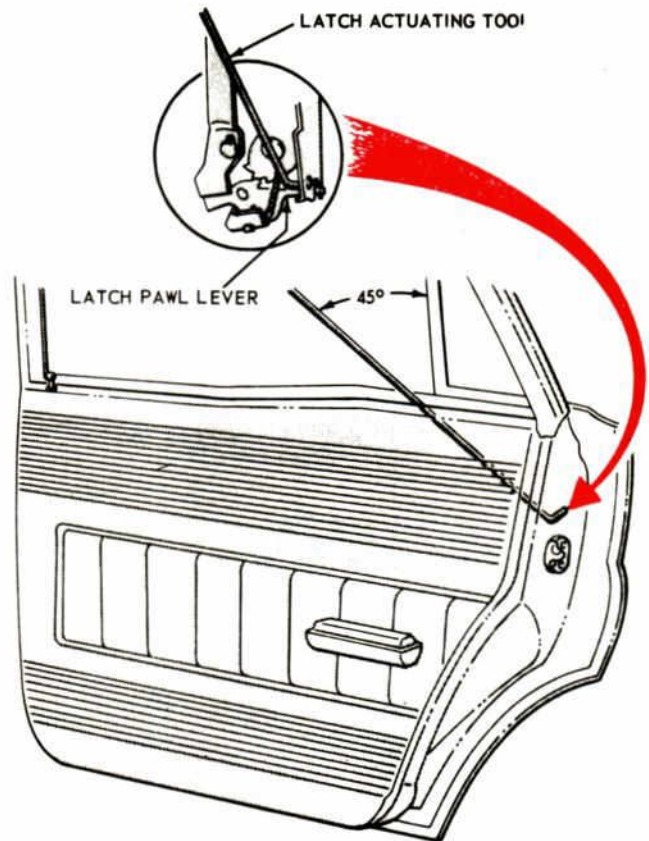
Fig. 3—Latch Pawl Lever

NOTE: Because of the stationary vent window design used on the Mercury Intermediate, Fairlane and Falcon sedan and station wagon rear doors, it will be necessary to approach the latch on these units with the rod at an angle of approximately 45 degrees as shown in Figure 3. A slight pressure on the latch pawl lever will unlatch the door.

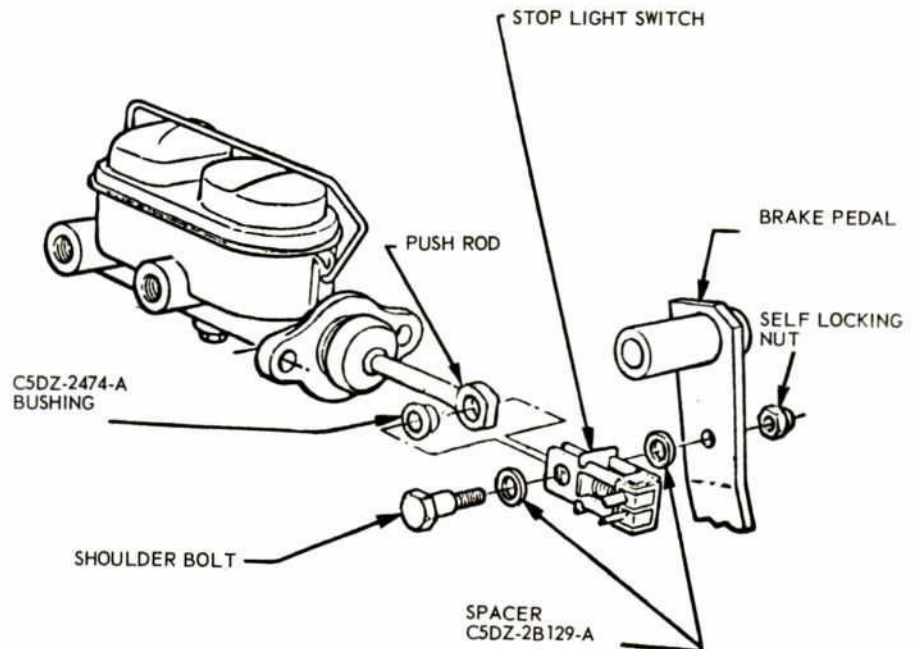
Fig. 3—Stoplight Switch

Whenever service to the stop light switch or adjacent areas (Fig. 3) is required, the installation procedures in this article should be followed, or the stop lights may operate continuously without applying the brakes. Special attention should be paid to the possibility of misalignment. Attach the stop light switch to the master cylinder and the brake pedal as follows:

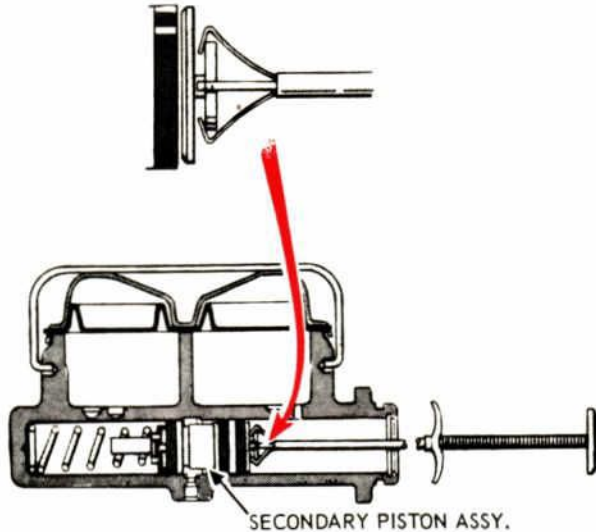
SECONDARY PISTON ASSEMBLY REMOVAL ON THE DUAL MASTER CYLINDER

It is possible to remove the dual master cylinder secondary pistons by pressurizing the master cylinder and forcing the piston out of the assembly. This method of removing the secondary piston from the master cylinder is *not* recommended.
